Report on the Investigation of  
the grounding  
of the passenger ferry  
***Trident V***

In the Alligande Passage, approaches to Herm Island

On 22 April 2016

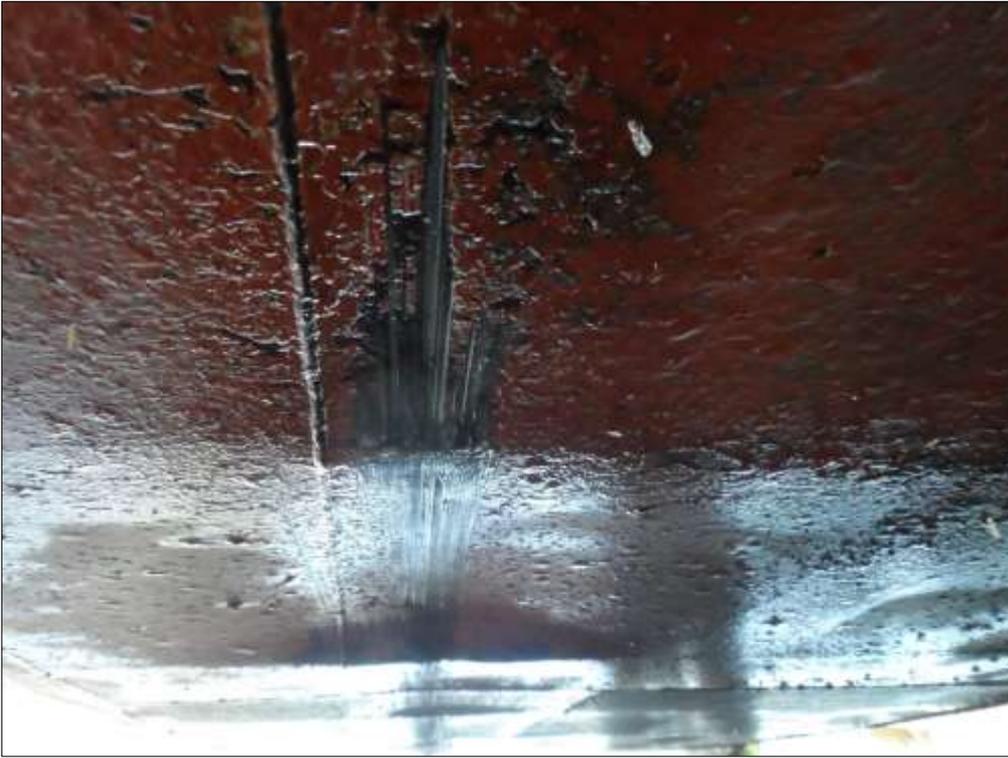
The shell plating of the starboard tank space (forward of the engine room) was subject to contact damage. **(Figures 1 & 2)**

**Figure 1:** Shell plating damage to starboard hull

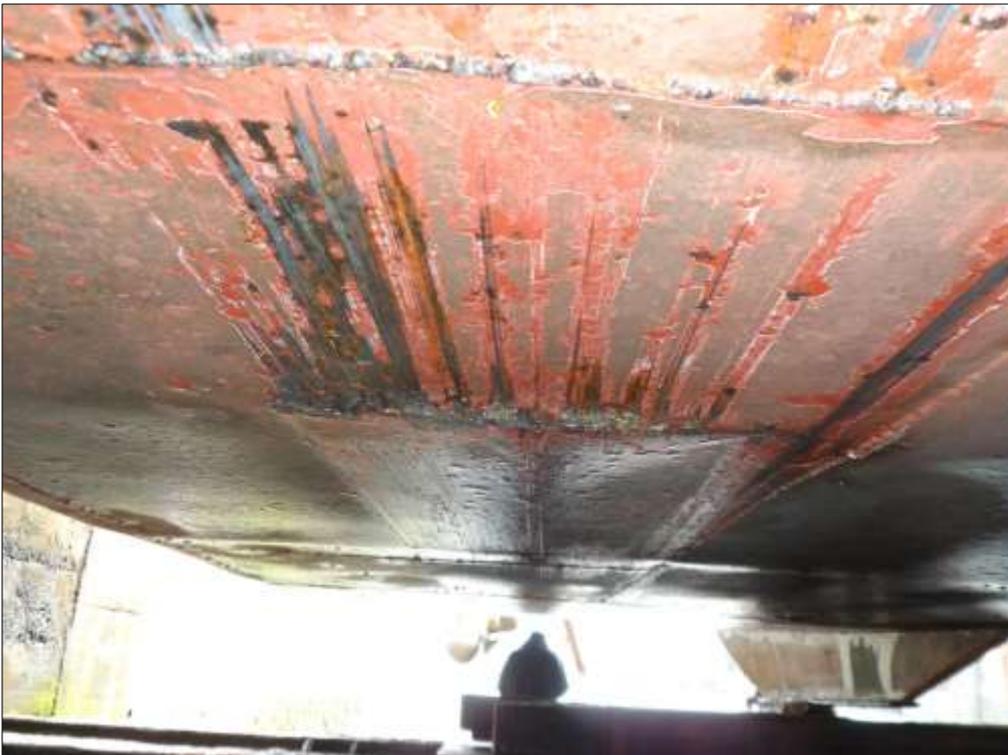
**Figure 2:** Shell plating damage to starboard hull

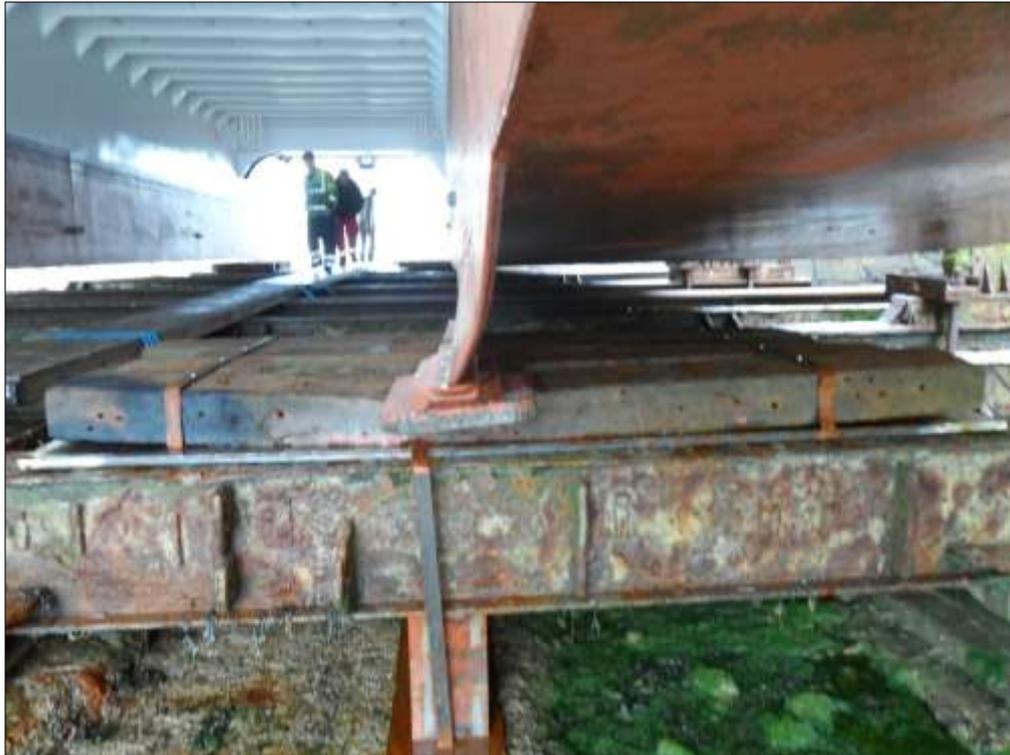
The skeg of the starboard hull was distorted. **(Figure 3)**

**Figure 3:** Distortion to starboard skeg

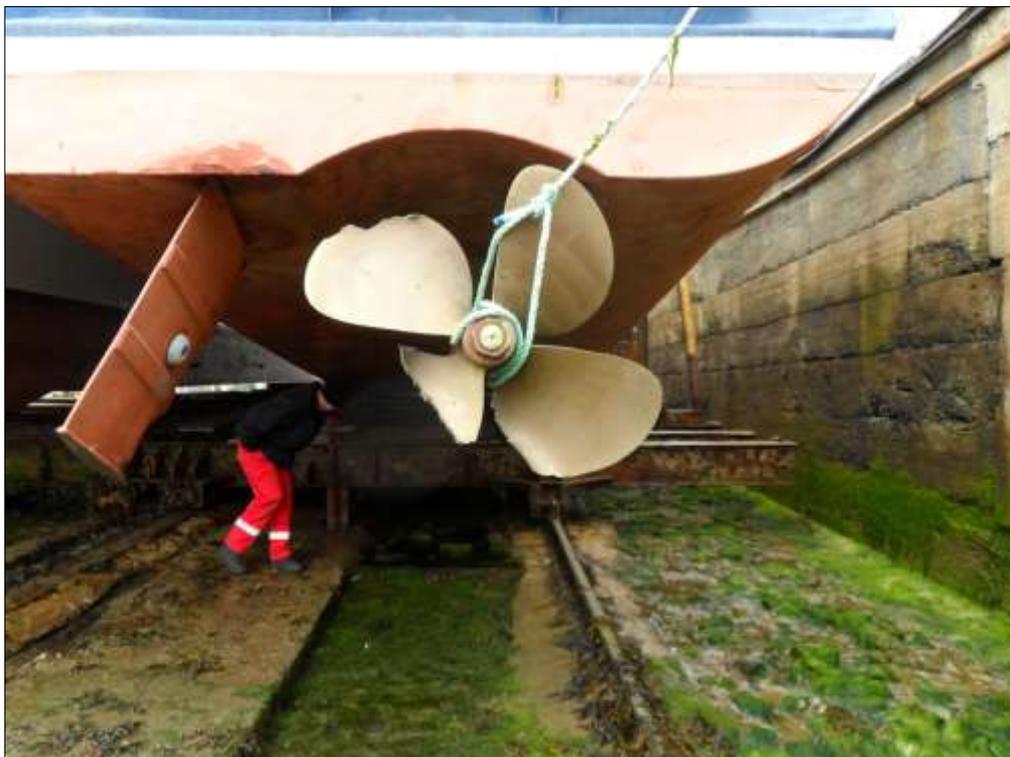
The starboard rudder was heavily distorted out of position with contact damage to the rudder itself. **(Figure 4)**

**Figure 4:** Starboard rudder distorted out of position

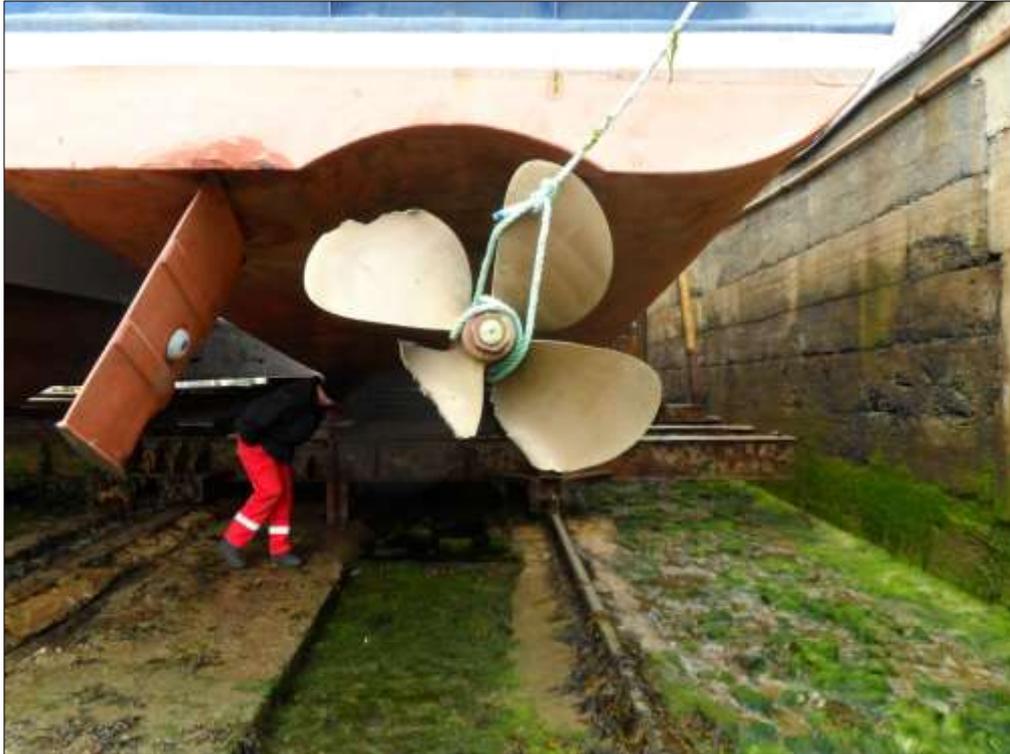
The starboard propeller blades were heavily distorted or missing. **(Figure 5)**

**Figure 5:** Starboard propeller blades heavily damaged or missing

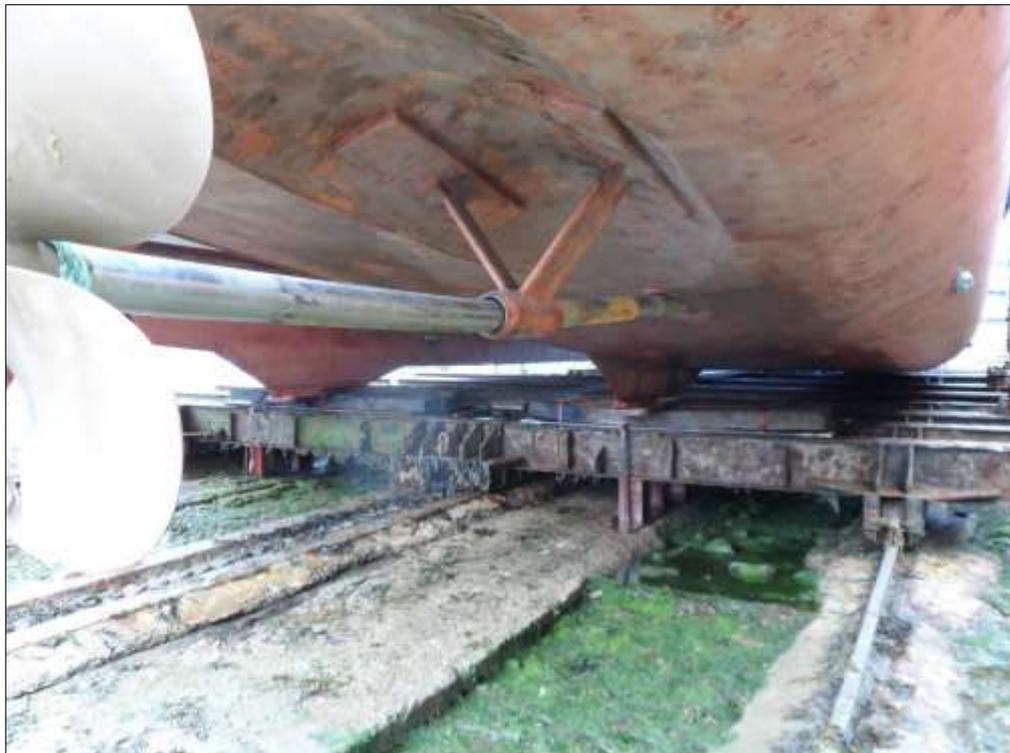
The starboard shaft and 'P' bracket were distorted with contact damage. **(Figure 6)**

**Figure 6:** Starboard shaft and 'P' bracket distorted

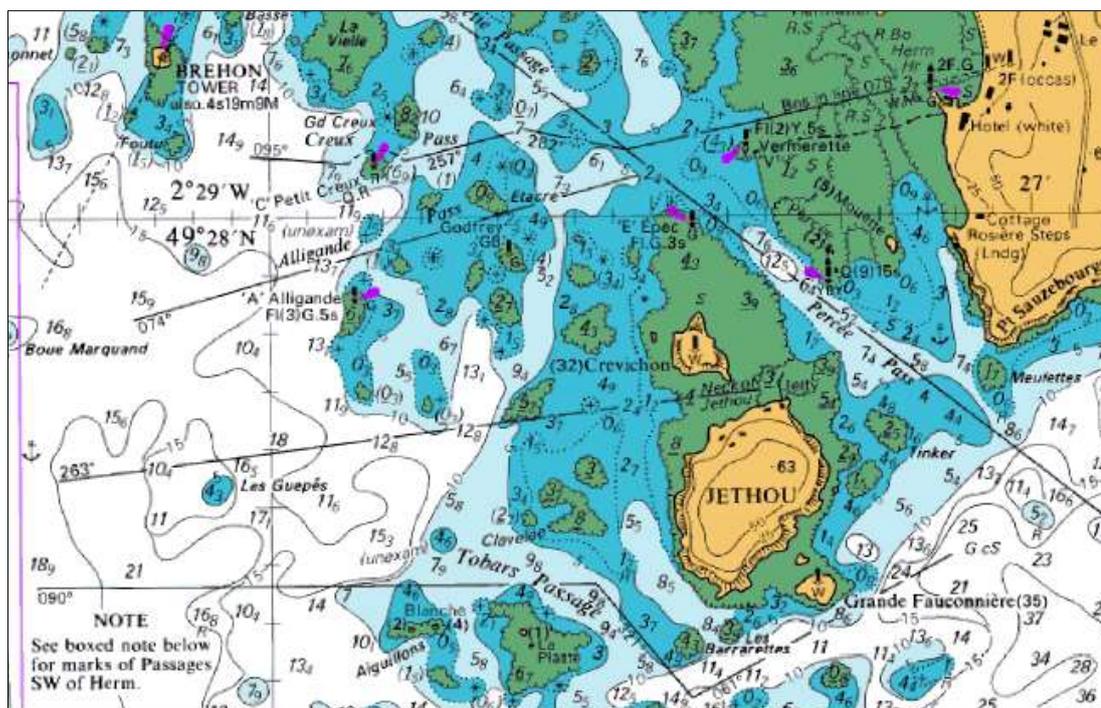
Figure 7: Admiralty chart extract of Alligande Passage

It is clear that the charted 074° track passes close to a number of hazards both to the north and south, and strict track control is required. The visual transit to maintain the track is Vermerette Beacon in line with Herm harbour pierhead white patch. This is followed until either the Percee passage track is adopted or the approach into Herm harbour, depending on the height of tide.

The absence of leading transit marks due to restricted visibility meant that it was not possible to visually monitor the vessels position and that it was vital that radar navigational techniques were employed to ensure strict monitoring of the vessels position in relation to the hazards.

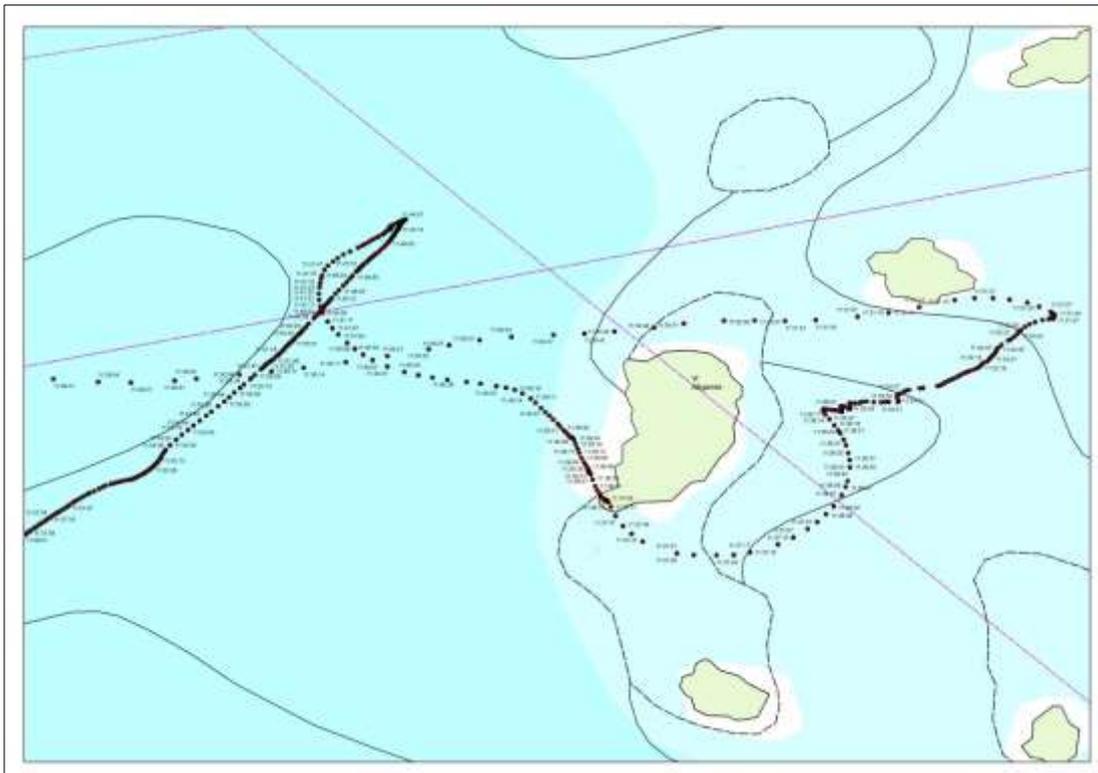
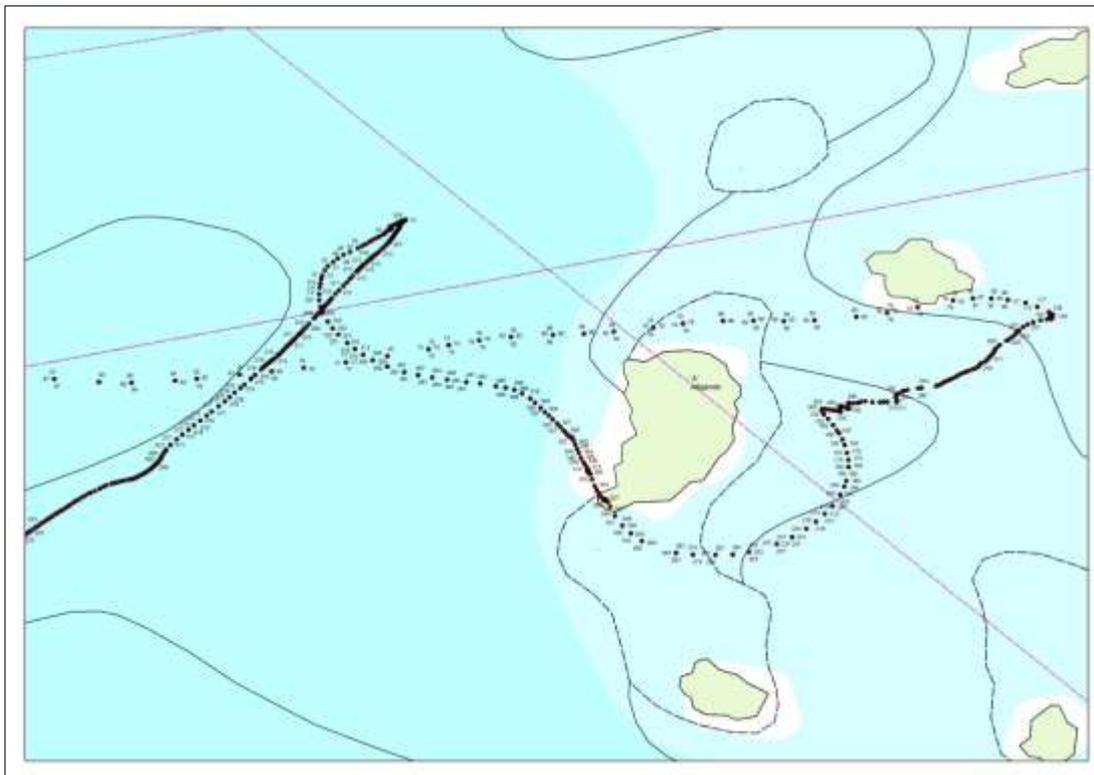
**Figures 8 & 9** show the AIS track of time and COG taken by the vessel. It also shows the charted 074° track (magenta). In the approach to the grounding, *Trident V* was always to the south of the approved track. The vessel then passed perilously close south of Tasse before being manoeuvred into safe water.

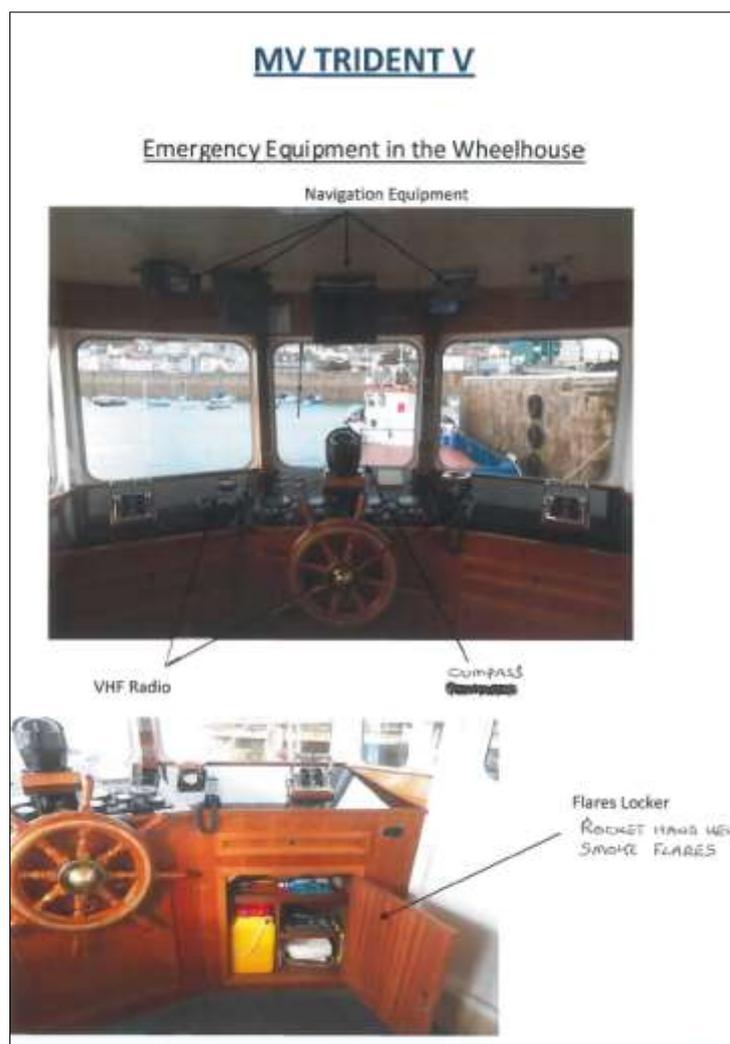
**Figure 10:** Extract from Safety & Emergency file showing wheelhouse configuration

The layout of the wheelhouse with the main radar fitted to the deck head on the centreline restricted options on configuring the team. The Master, who is primarily responsible for navigation was only able to observe the radar if stood at the helm. This meant he could easily be distracted by course keeping rather than interpreting the radar picture. The configuration of the rudders in relation to the shafts makes helming the vessel difficult as it is directionally unstable. The sister vessel *Trident VI* had the rudders reconfigured following a grounding but this alternation was not made to *Trident V*.

This also prevented the Engineer having ready access to the radar and, in turn, adversely affected the level of support he could give to the Master. **Figure 10** is an extract from *Trident V's* Safety & Emergency File showing the layout of the wheelhouse.
