FLYER TO FISHING VESSELS AND SMALL CRAFT
GU121 MAR-ROSE – SINKING - GROIS ROCKS, ALDERNEY
25 JULY 2016

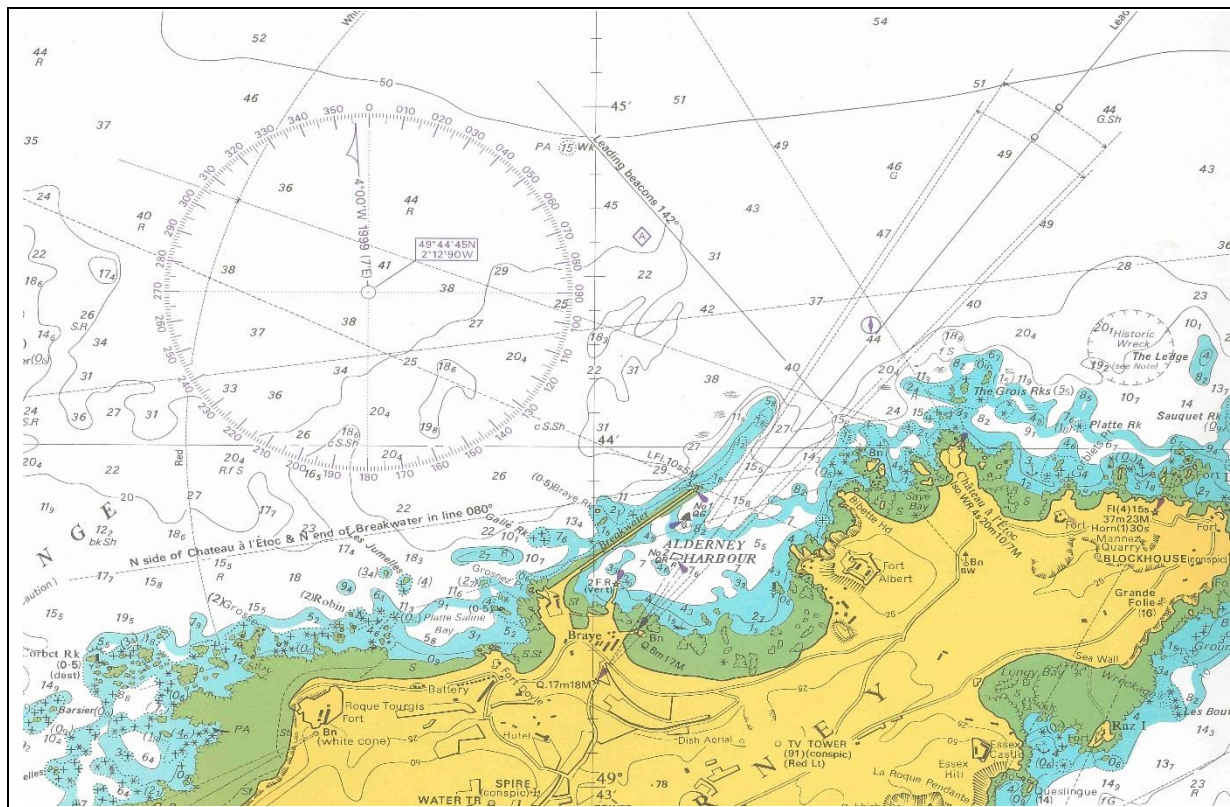
The weather was fine with good visibility and a flat calm sea. Low Water was 05:03 at 1.7m. The vessel departed Braye Harbour at 06:50, (**see fig 2**), heading for the fishing grounds to the East at the Alderney Race, via the outer Grois Rocks.

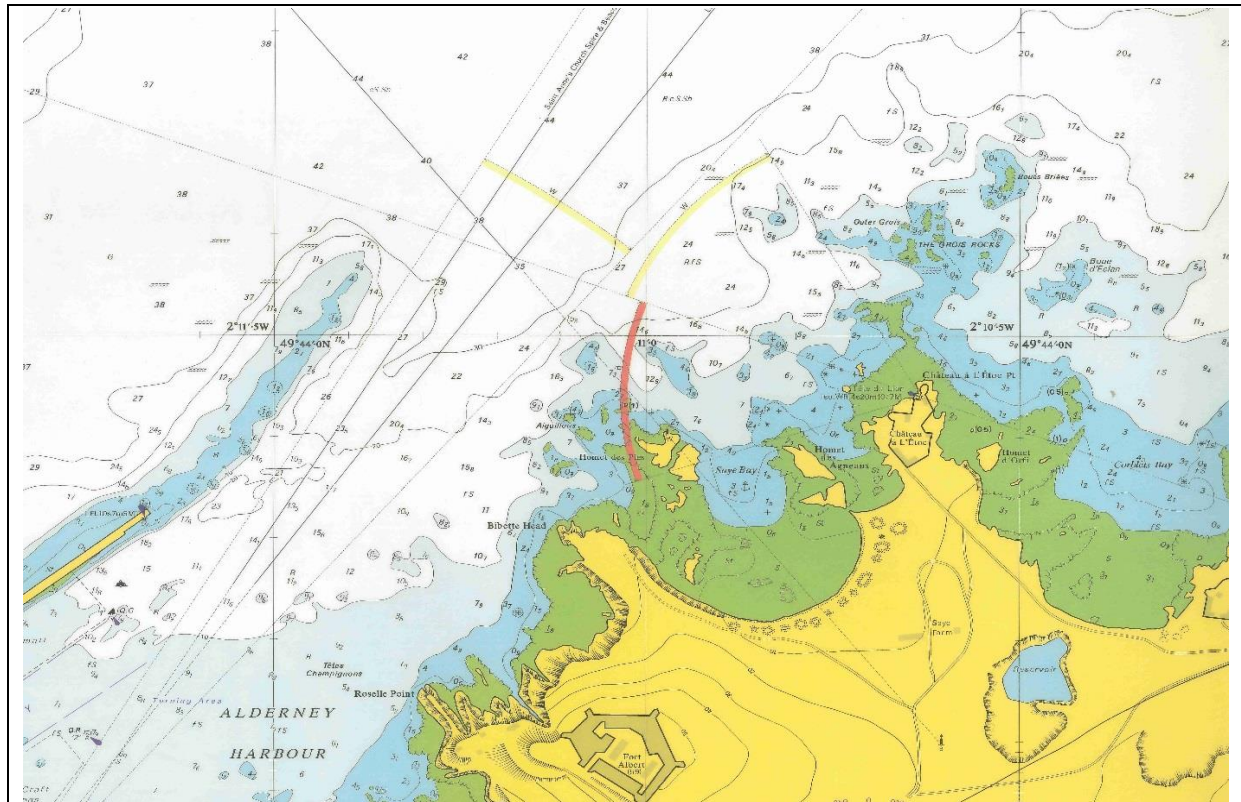
The Skipper was on the wheel and the crew member was sitting on the bin rack. As the skipper committed the vessel to the Grois Passage, (**see fig 3**), the sun was low in the sky and glare was coming off the surface of the sea.

Approximately 200m into the Passage, the skipper felt the vessel touch bottom, causing enough damage to ultimately sink the Mar-Rose. This was due to the vessel being off the visual and clearing marks, leading to insufficient under keel clearance. The vessel quickly developed a list to port and became bow heavy, with the high water level bilge alarm sounding.

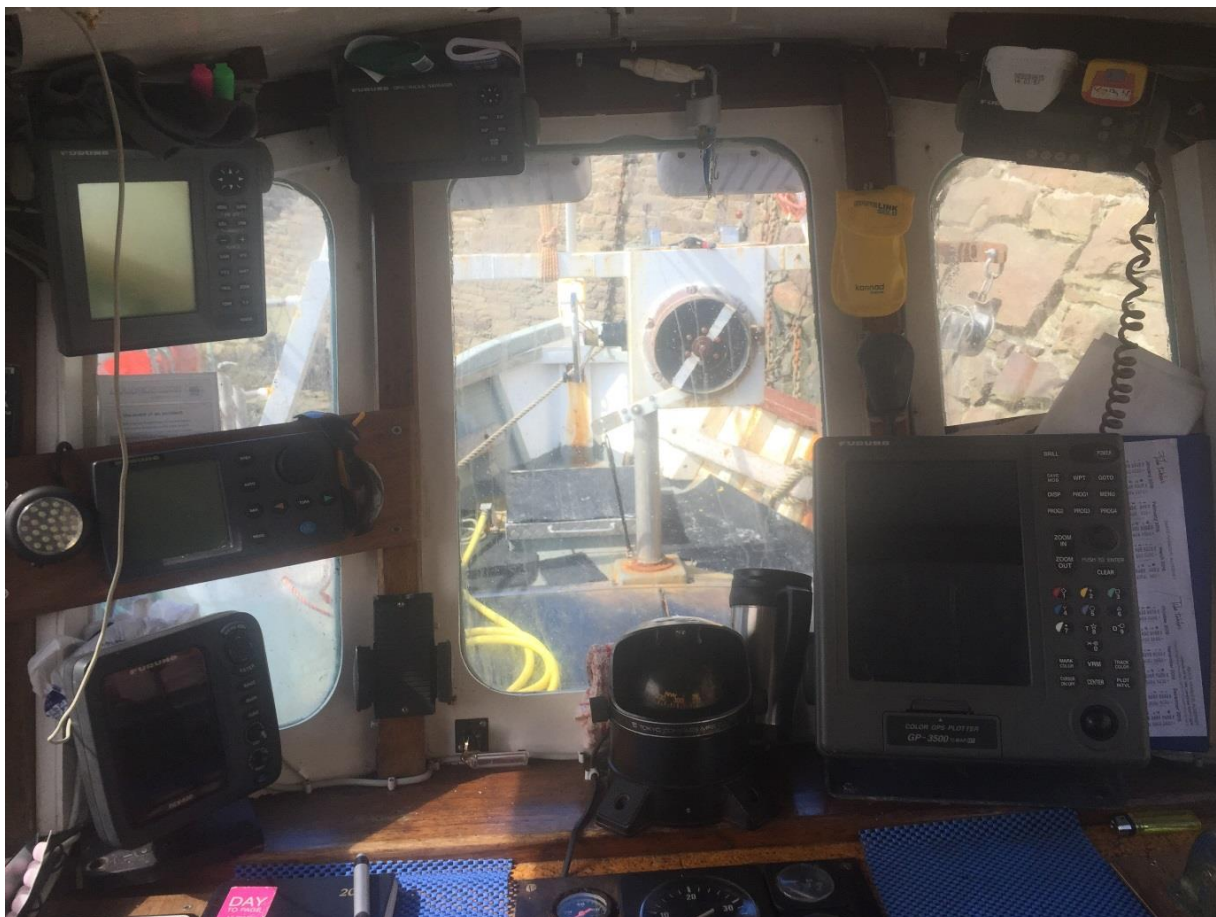
Figure 4: Wheel House Configuration

- Glare was coming off the calm sea restricting the skipper's ability to see clearly.
- The wheelhouse instrument configuration was such that it further restricted the skipper's visibility. **See figure 4.**
